**Clean Michigan Initiative  
Nonpoint Source Grant**

Tracking code #2002-0039

## Munising Bay-St. Martin's Hill July 31, 2004 through June 30, 2006

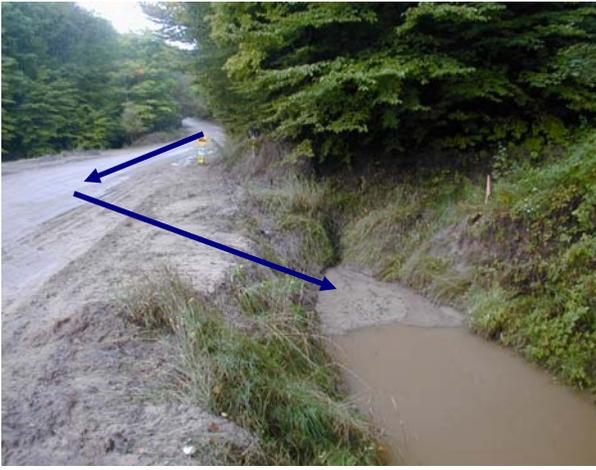
**Before:** Due to large amounts of sediment runoff—denoted by the arrows—a sediment basin at the downslope end of the road filled up rapidly and sediment discharged into Lake Superior.

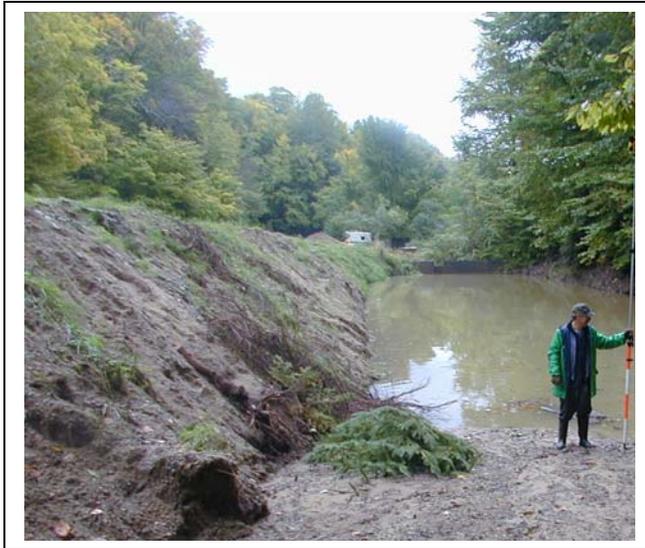
**Before:** During rain events storm water flowed into the old sediment basin, causing deep gulying along the entire stretch of road.
